Victoria to Esquimalt Cable Replacement Project – Community Construction Report #14

June 2026

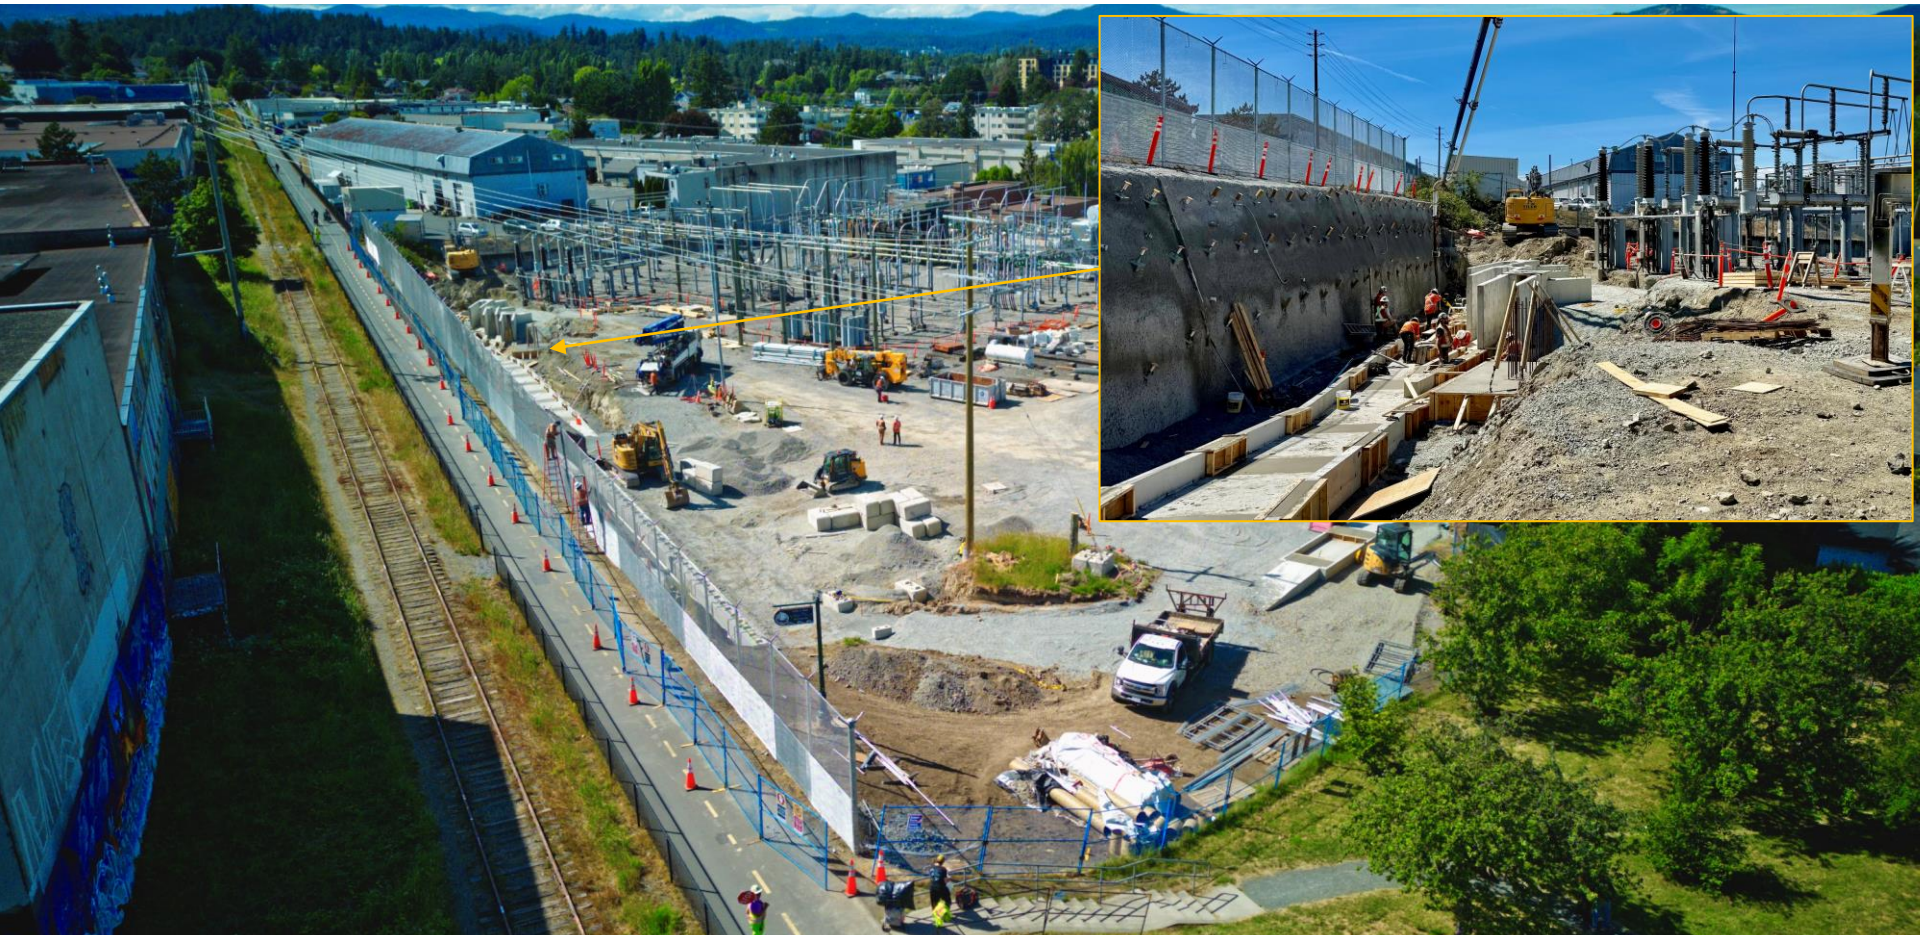
Construction photos: Esquimalt Substation

June 11: Work on the fence along the edge of the substation facility and the E&N Trail. Inset photo: ongoing cable duct bank work.

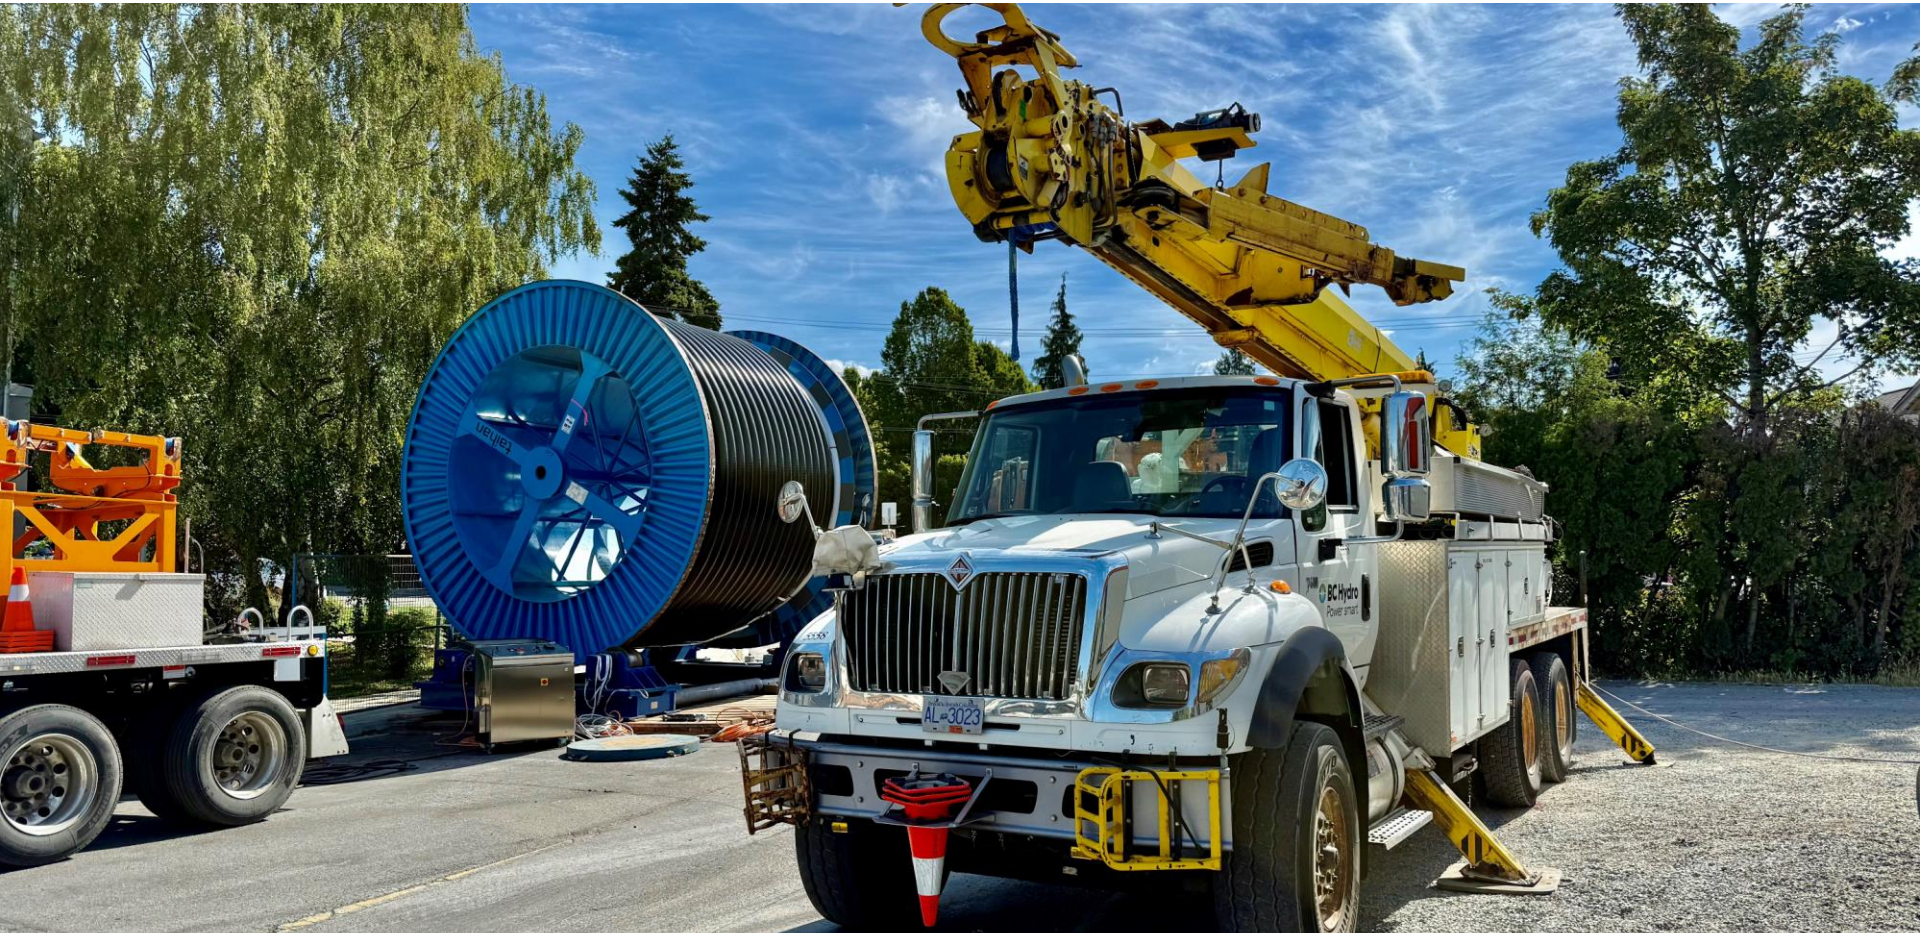
Cable pulling photo: Esquimalt Substation

June 23: Cable reel on Devonshire Road and preparing to pull cable through the new duct bank within the Esquimalt Substation.

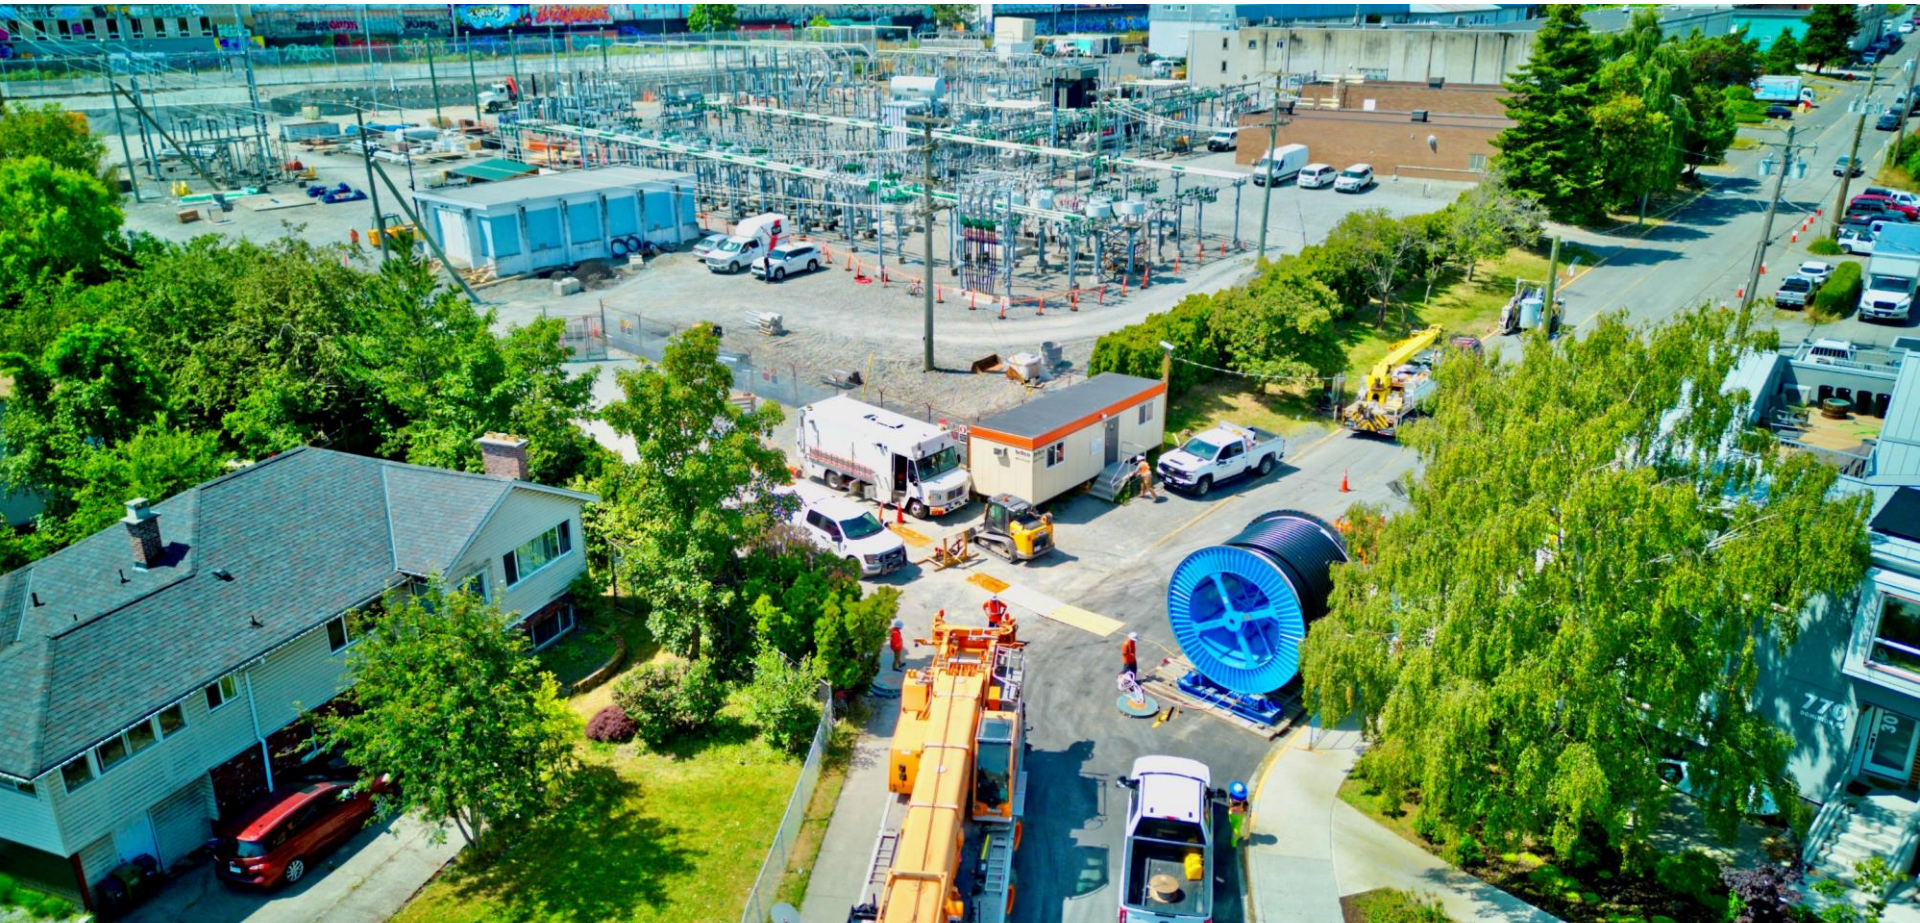
Cable pulling photo: Esquimalt Substation

June 23: Cable crews getting ready to pull cable into the substation.

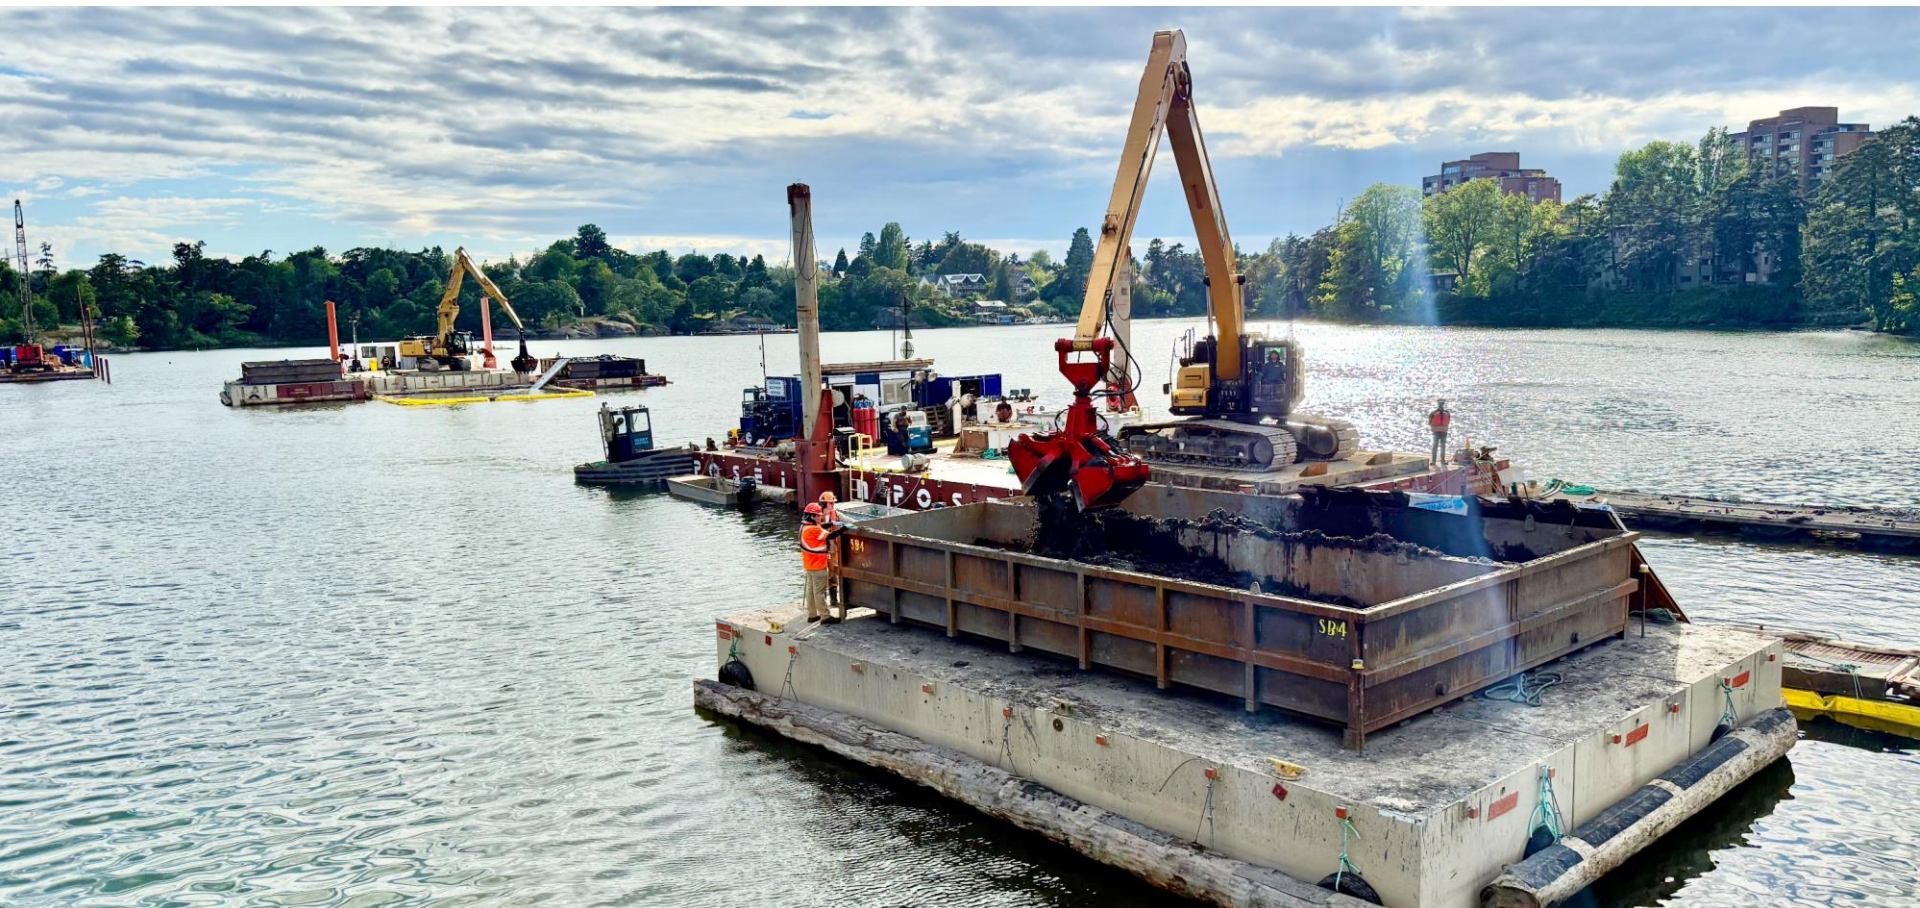
Construction photos: Gorge Waterway

June 3: High tide and the barges in place and working. Two barges and excavators operating to remove sediment for the trench. An archaeology monitor, with a Songhees First Nation member supporting, watch the removed sediment. No archeological material has been found to date.

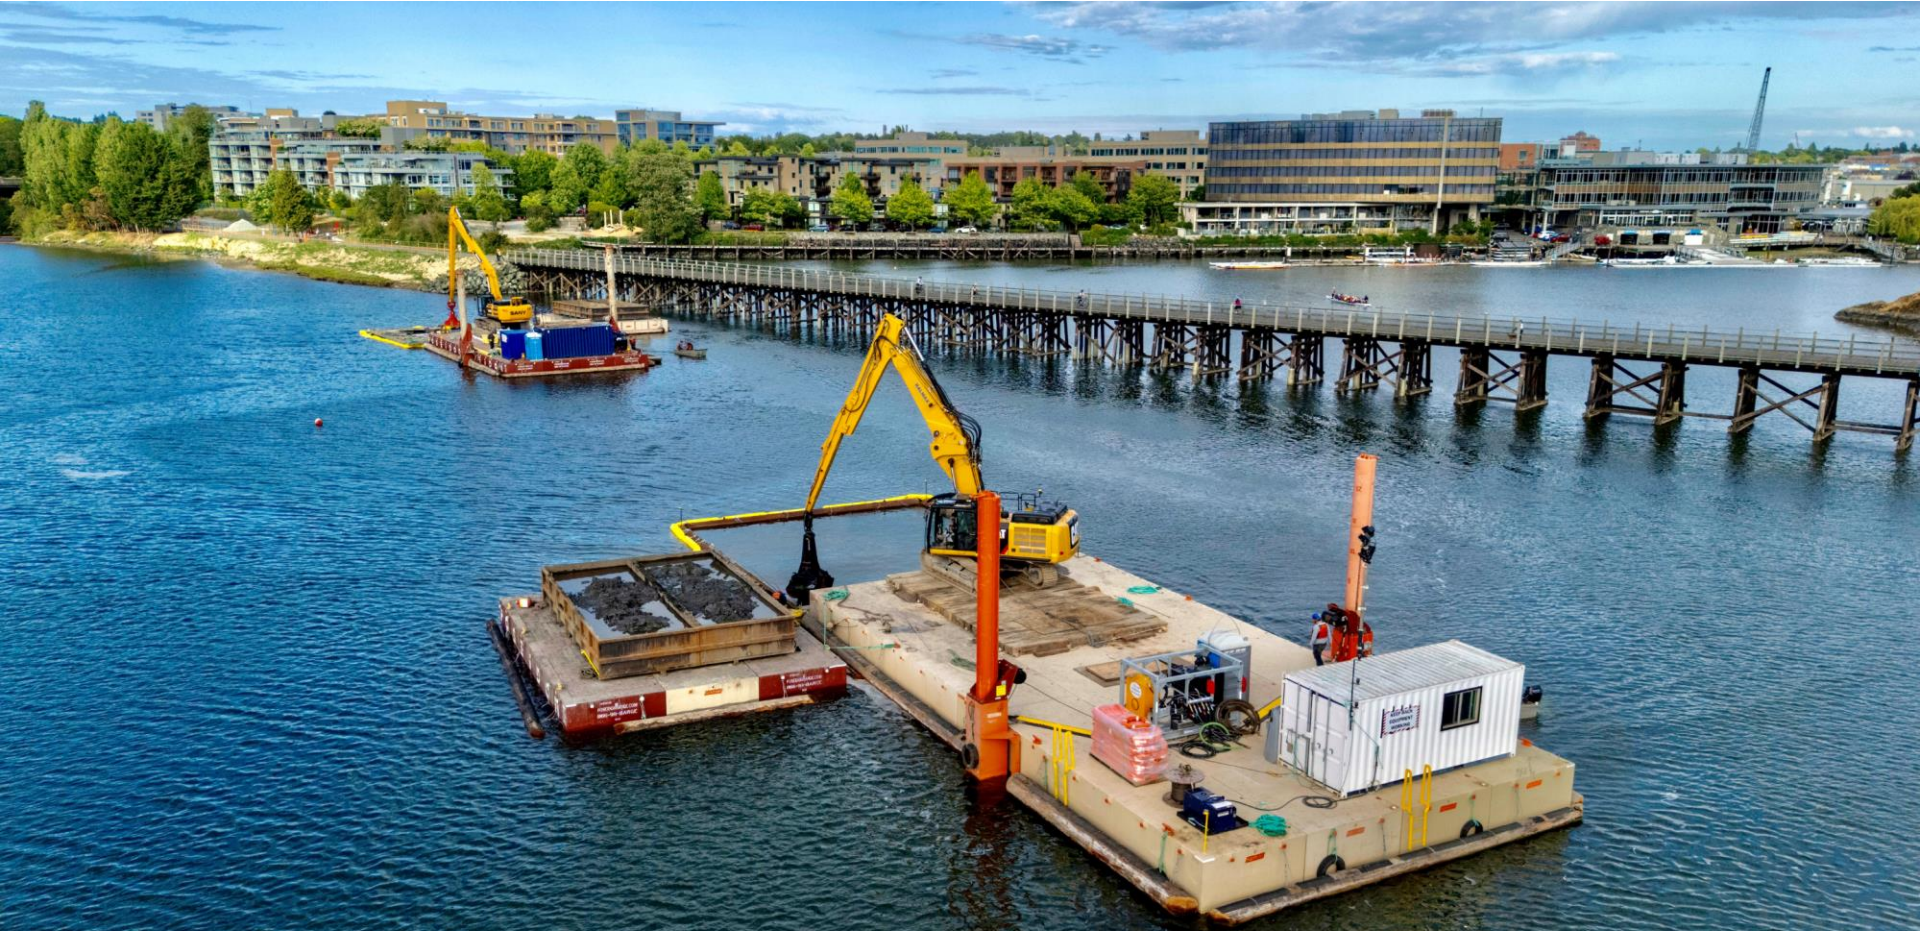
Construction photos: Gorge Waterway

June 3: Barges and equipment on the west side of the Selkirk Trestle. Viaduct Park is in the background.

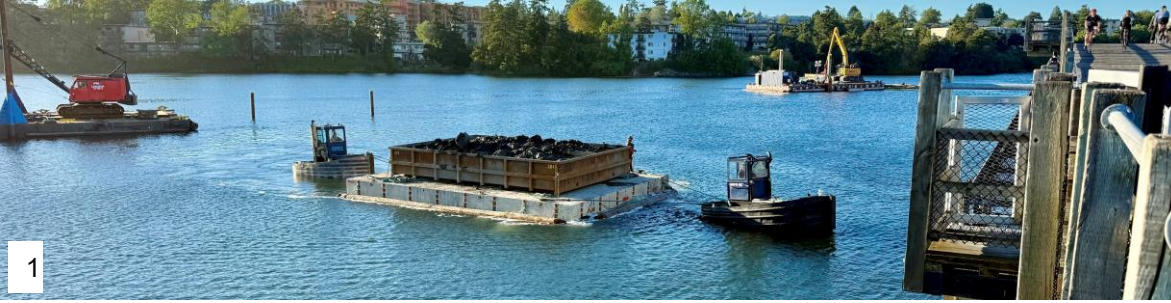
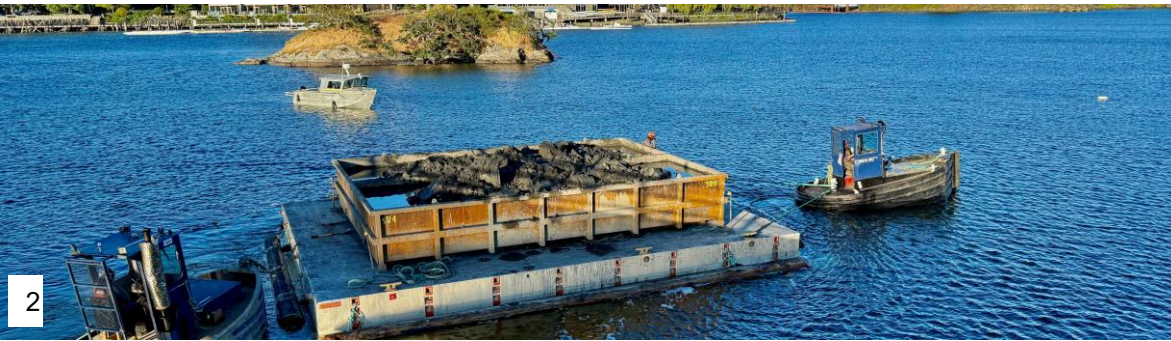
Construction photos: Gorge Waterway

Project marine traffic route within the Gorge Waterway.

- June 11: Sediment barge movements.
- Photo 1: A full barge moving towards the Selkirk Trestle opening.
 - Photo 2: Thru the trestle opening and turning right to avoid a shallow rock outcrop
 - Photo: Dusk, and another full barge moving past the Selkirk Trestle.

The blue arrows in the map above show the path of sediment barges for off-load and return.

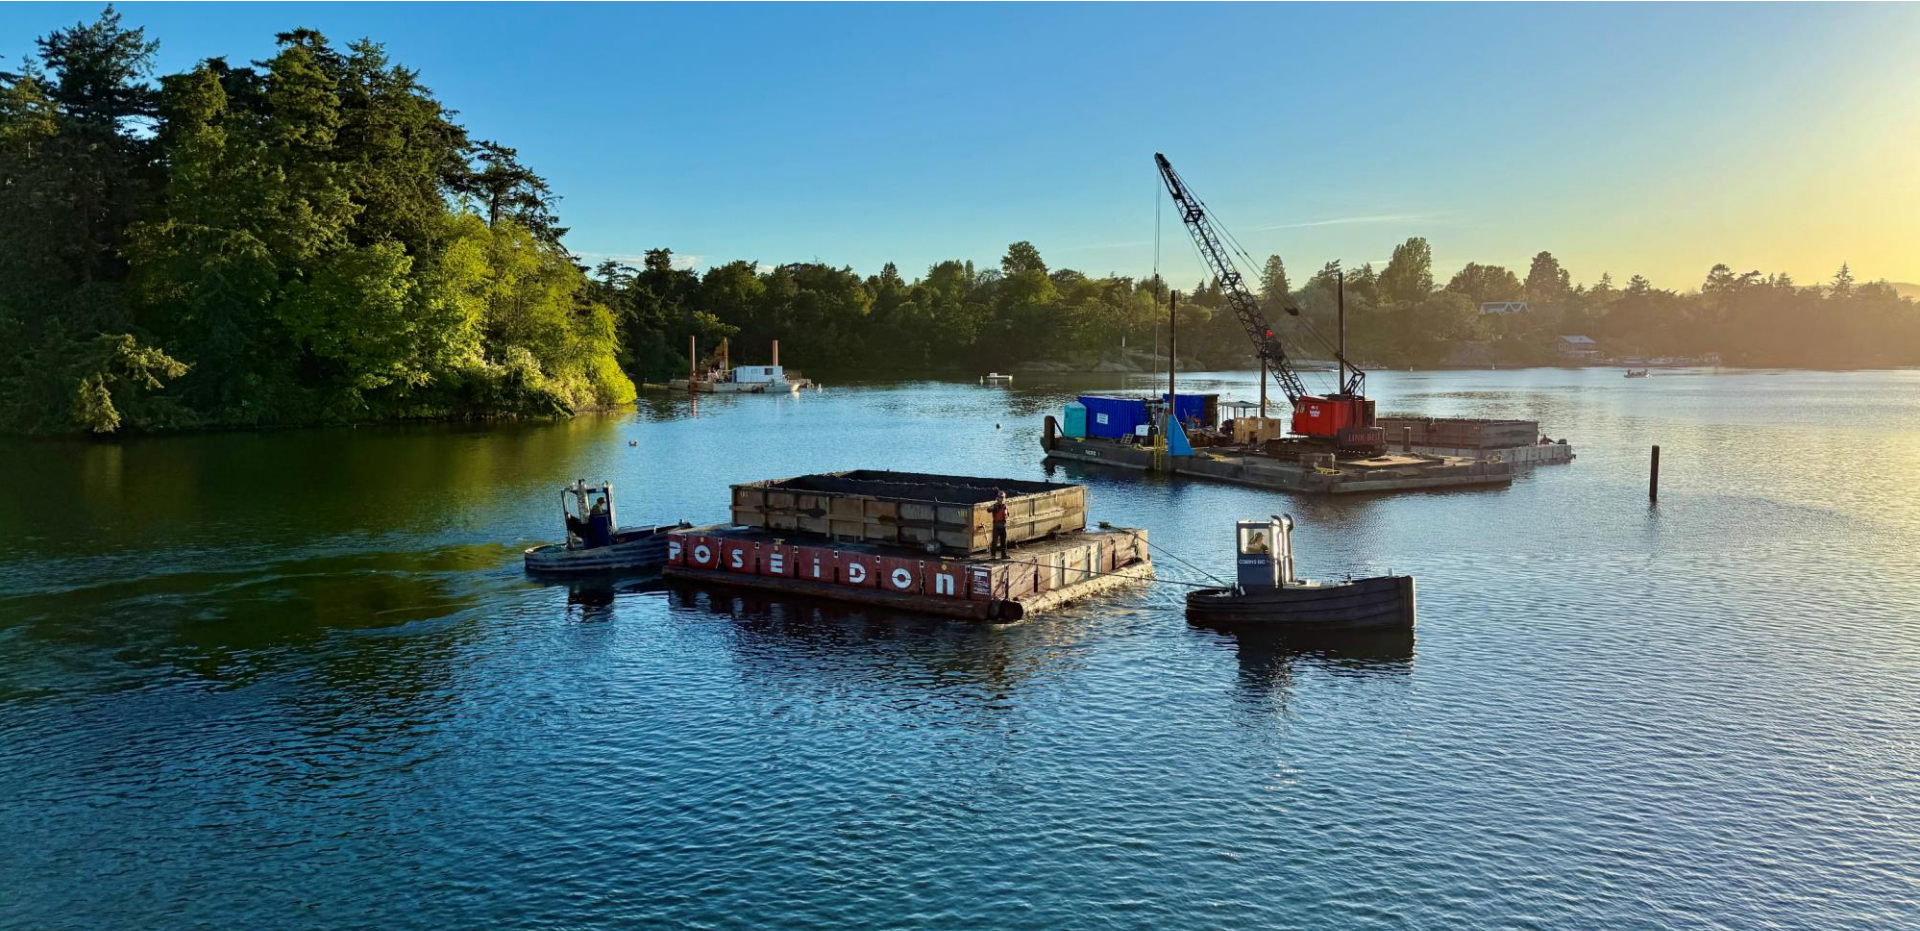
Construction photos: Gorge Waterway

June 11: Evening view of the work area by Banfield Park and an empty sediment barge moving into place to be refilled.

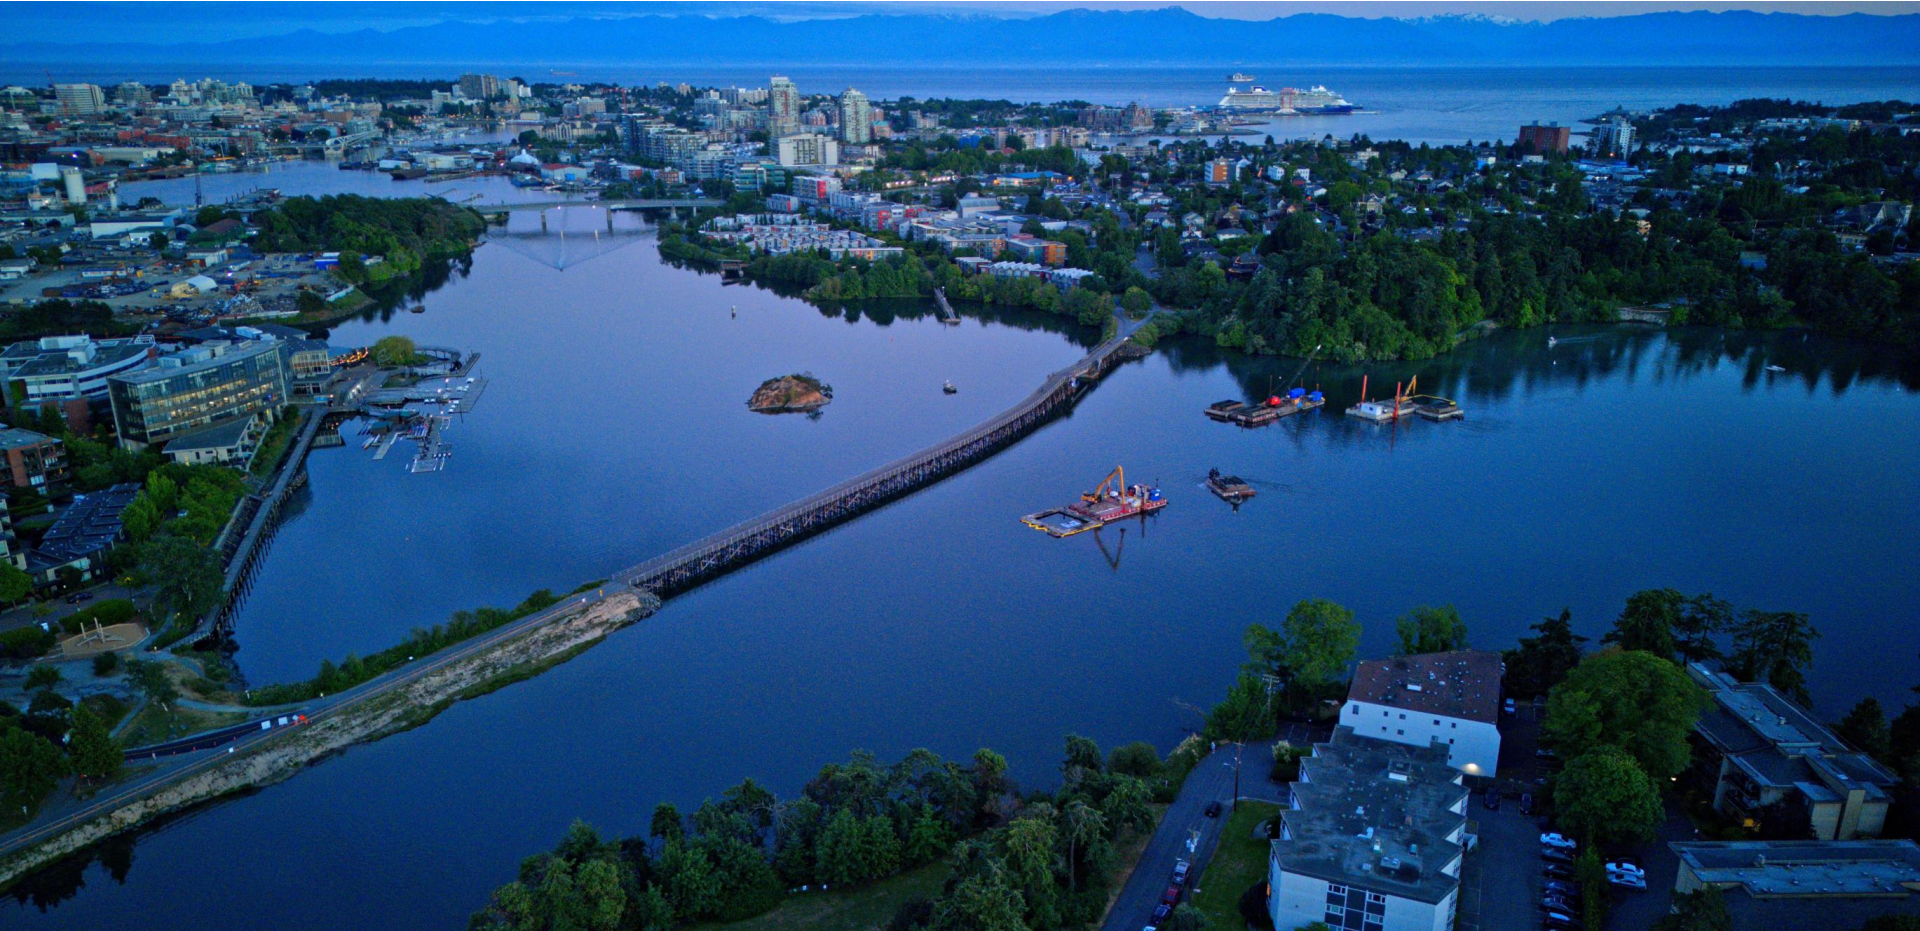
Construction photos: Gorge Waterway

June 11: A wide view of the work area and Victoria.

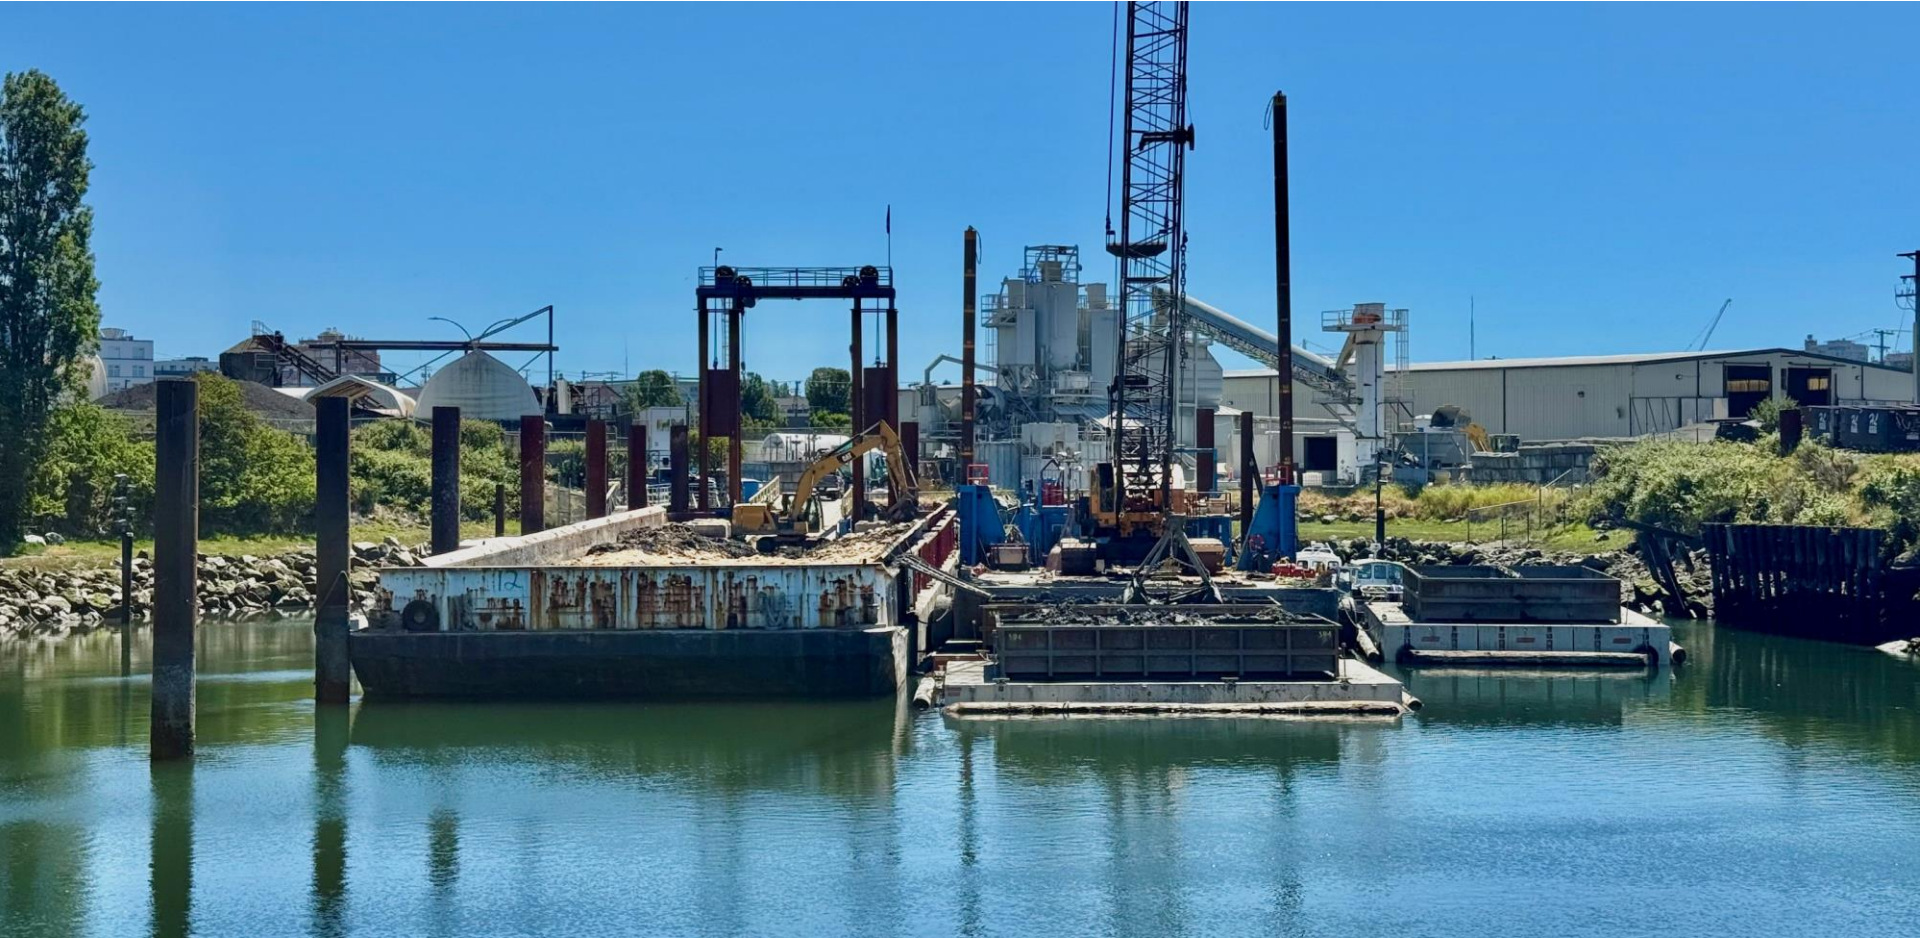
Construction photos: Gorge Waterway

June 18: Marine sediment off-loaded from the smaller barges into a large barge for transport to a disposal facility in the Lower Mainland.

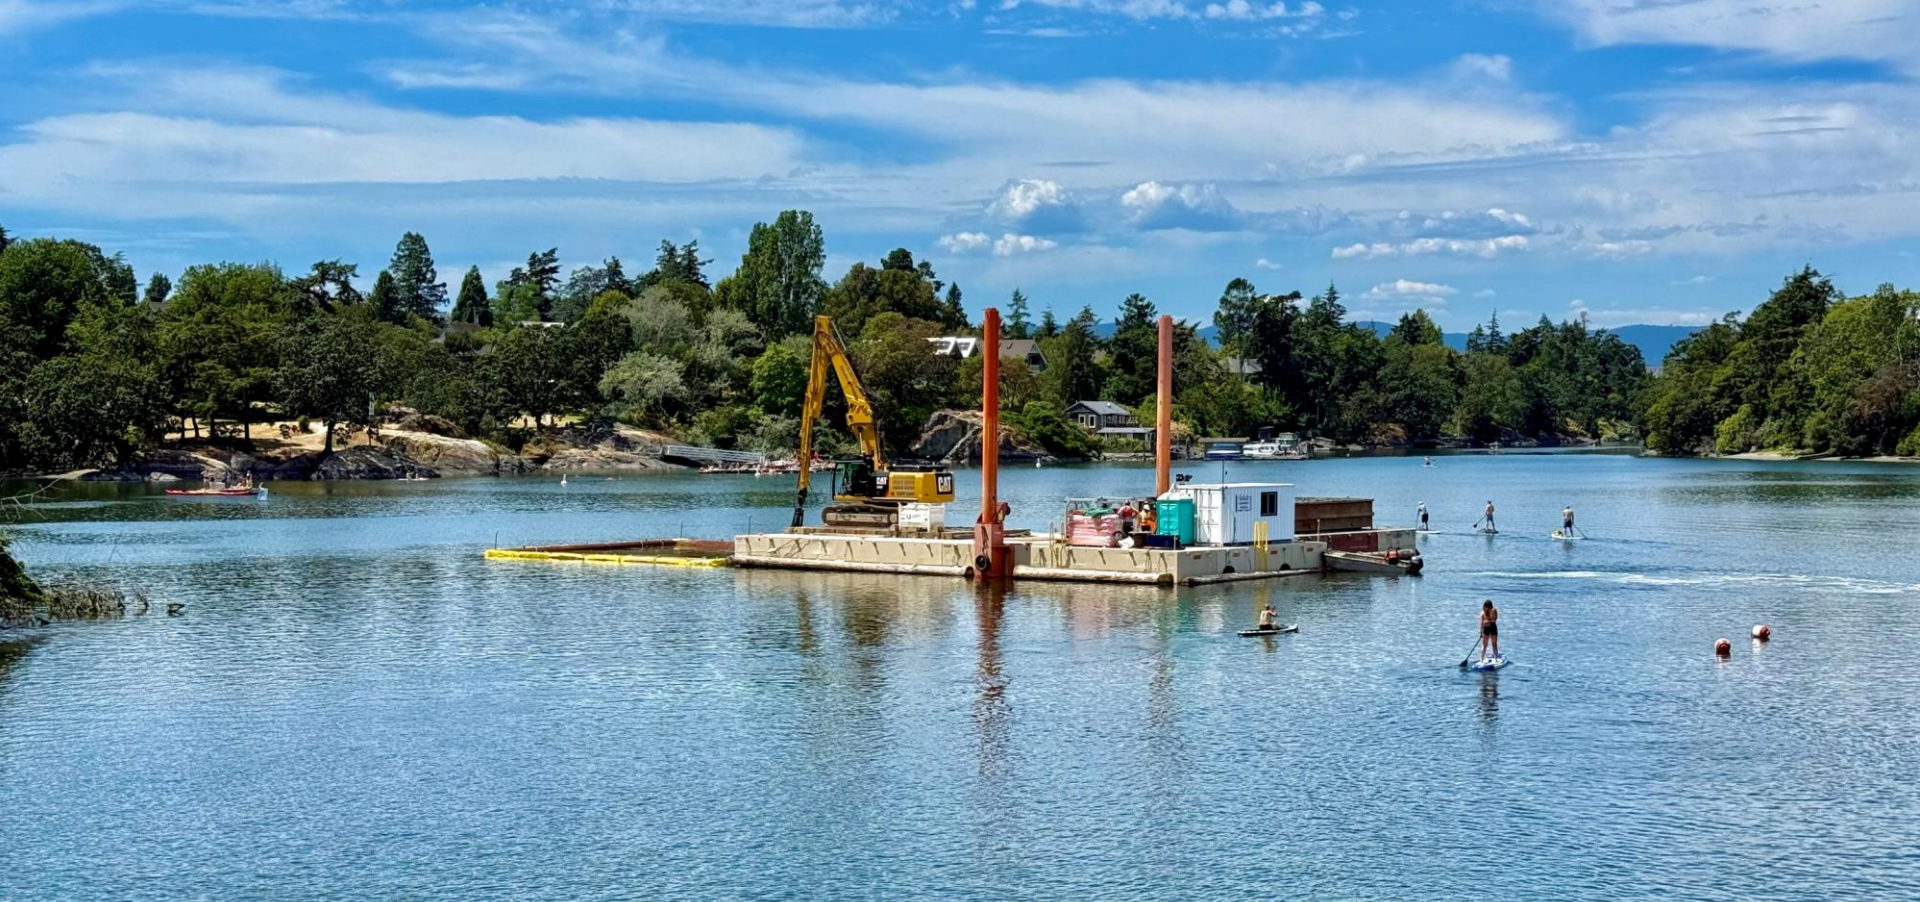
Construction photos: Gorge Waterway

June 23: Barge and equipment moving into place at Banfield Park to continue with the trench work. In addition to buoys, there is often verbal communication from crews to recreation users, in this case paddle boarders, on what direction to go when barges are moving.

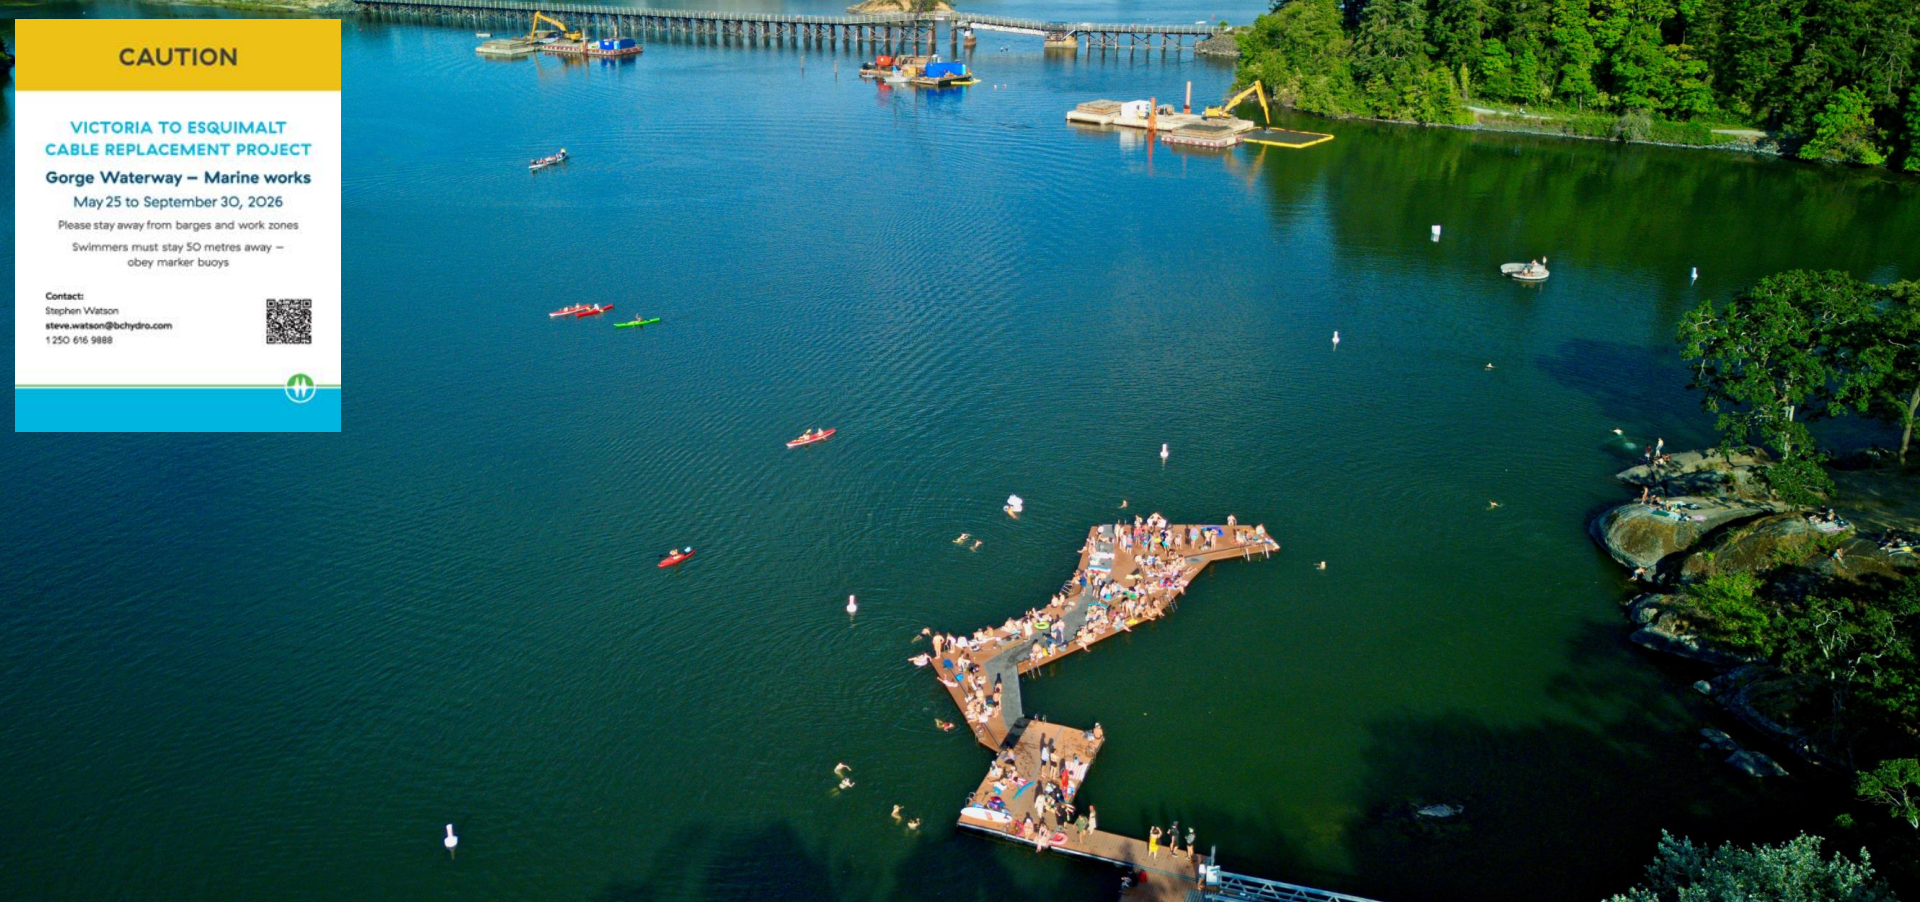
Construction photos: Gorge Waterway

June 23: Barges and equipment working during the higher ocean tide. A busy Banfield Park Dock in the foreground during a warm evening. The inset sign is posted on the dock walkway and around Banfield Park. No swimming within 50 m of work area signs are also posted on buoys.

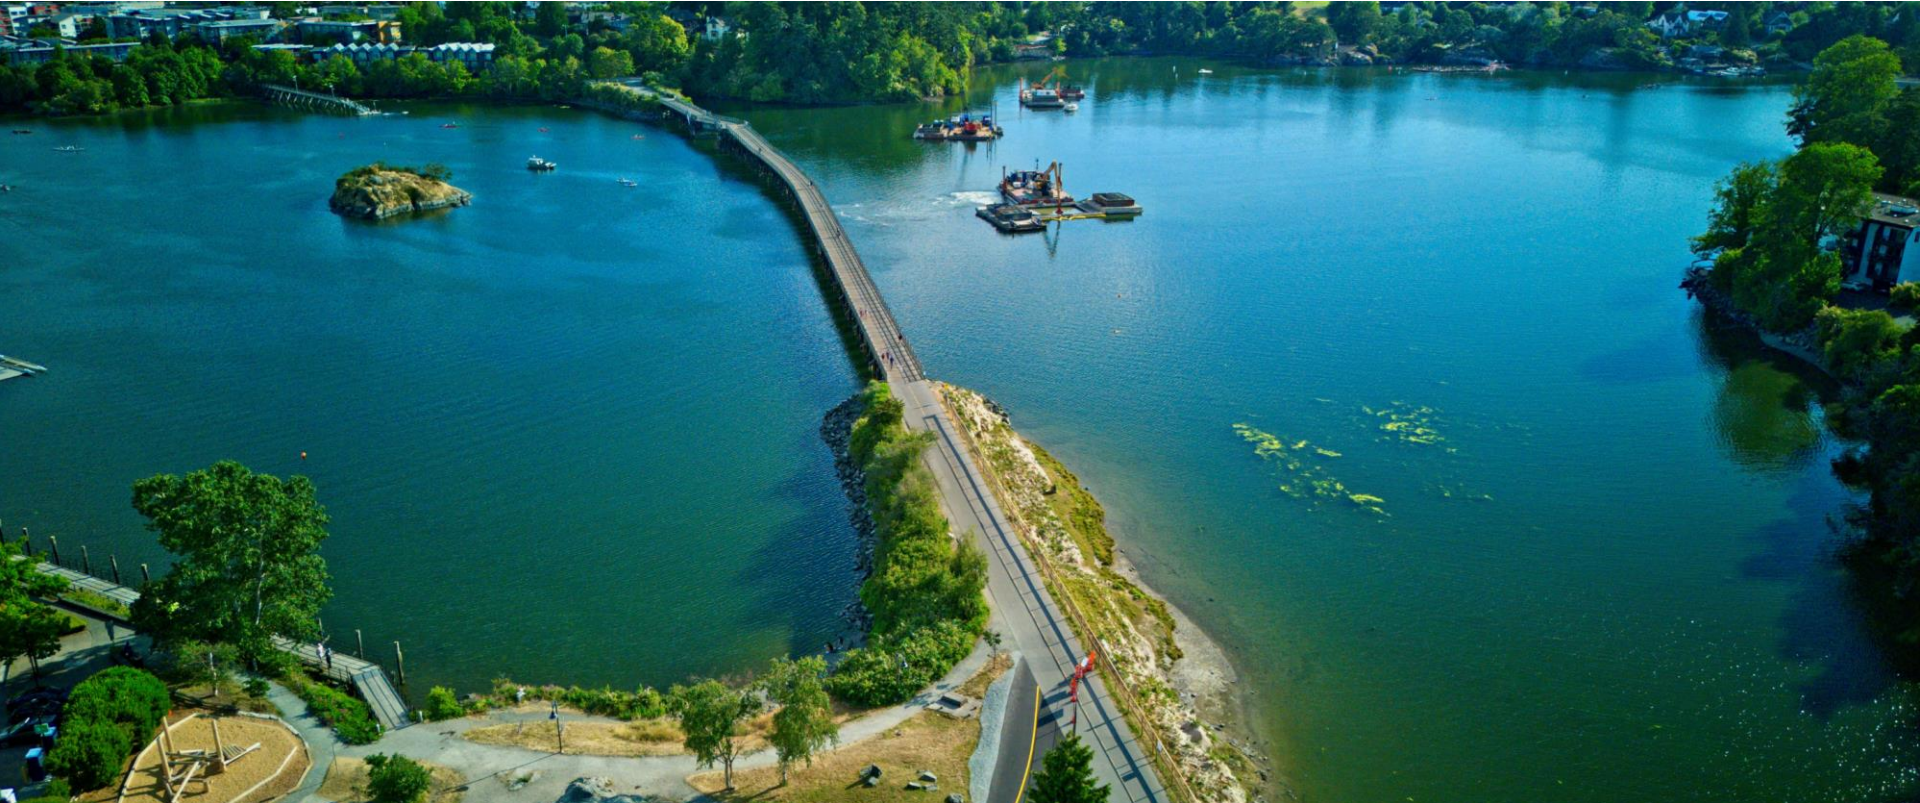
Construction photos: Gorge Waterway

June 23: Two barges and excavators working at two sites, with Viaduct Park in the foreground.

By the end of June, about 5,800 cubic metres of sediment had been removed. The marine trench excavation accessible by barge only is nearly complete. The total 660-metre-long trench length including foreshore to foreshore is 65% complete. Barge work will continue as crews place bedding material in the marine trench to prepare for the conduit placement in August. The full marine traffic closure for up to 10 days to allow for the sinking of the conduit, to the west side of the Selkirk Trestle, may begin around August 19.
